# Manhole Inspection Summary

Manhole # S23K1\_004MH

Insp Date: **11/25/08 2:25 PM**

**Location** Address: **2731 Marboune Ave.**

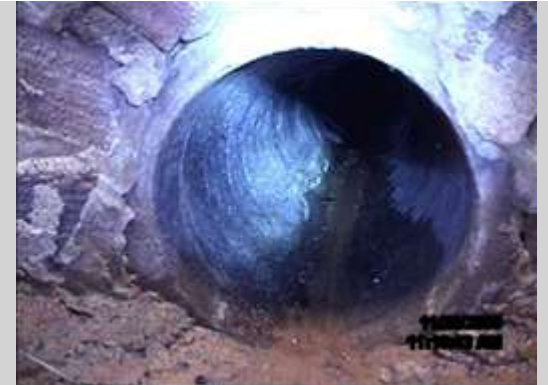
12 O'Clock Outflow

8 in. Circular Gravity Sewer  
Pipe Out @ 12 O'Clock

Pipe Height: **8.4** (in.) Rod and Bar (Angled)

Pipe Material: **Clay** ☐ Pipe Lined

Infiltration: **None** Pipe Seal Cond: **Sound**

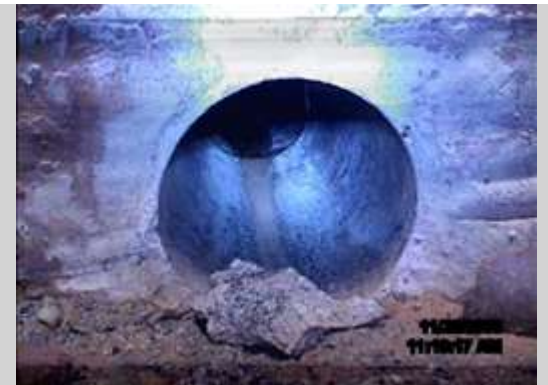
6 O'Clock Inflow

8 in. Circular Gravity Sewer  
Pipe In @ 6 O'Clock

Pipe Height: **8.4** (in.) Rod and Bar (Angled)

Pipe Material: **Clay** ☐ Pipe Lined

Infiltration: **None** Pipe Seal Cond: **Sound**
